**Project:** Lineside Building & Sale Reel Warehouse Demolition Adjacent to Live Railway Line

**Date:** January 2010 – April 2010

**Overview:** To Demolish Line side Railway Building, and Adjacent Sale Reel Warehouse

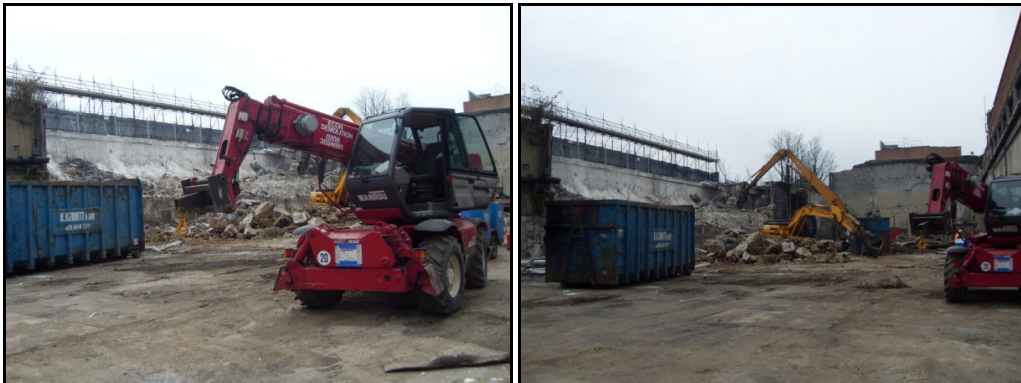
Methods/Technology: The steel framed line-side building demolished was approximately 75 meters in length and 10 meters in width with internal concrete bunkers which were also removed. The line-side building will be dismantled bay by bay removing steel clad sheets and steel purlins before removing steel trusses and uprights working progressively from east to west.

Complexity: The works were carried out with the live rails in the vicinity, so extra care had to be taken to ensure no damage to the railway infrastructure.
