Job Profile – Lee Station

Project: Riser Wall Rebuild

Date: November 2011

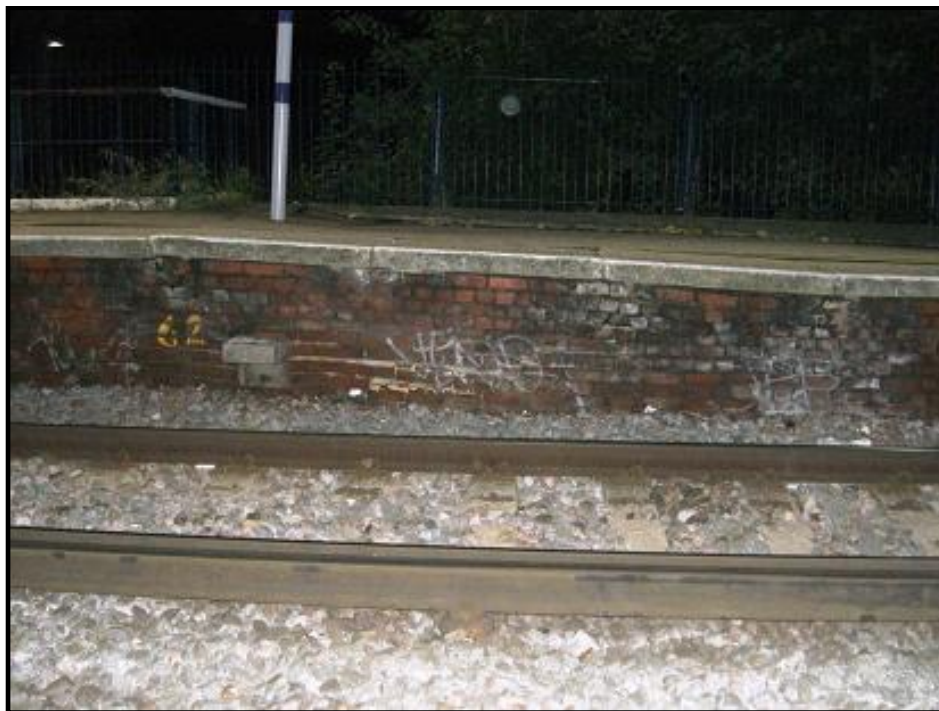
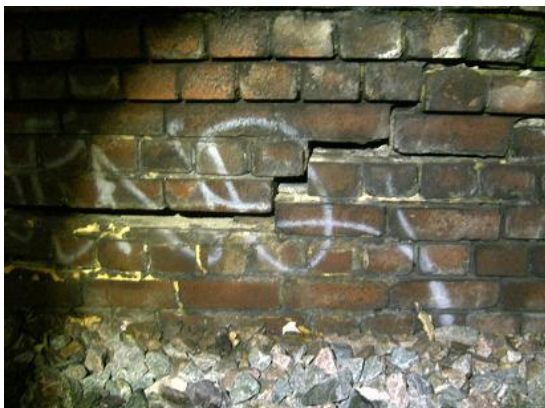
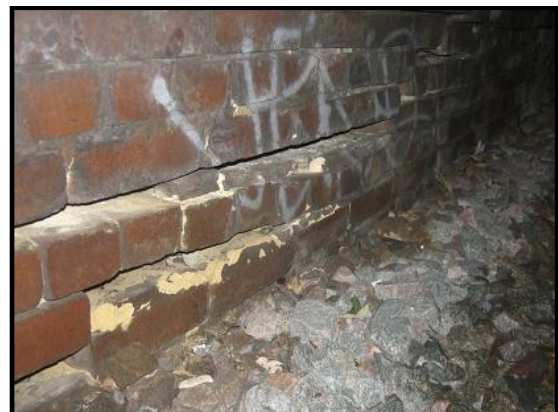
Overview: We were called to attend a fault where the riser wall had spilt on the lower section along the courses of the wall. The scope of works where to remove the damaged section of face brickwork and install a lintel below the ballast line and re-build on a like for like basis.

The two coping stones immediately above the damaged section were removed and stored for re-fitting, the face brickwork was then removed down to the ballast level allowing for brick bonding into the surrounding sound brickwork. A concrete lintel was then installed to enable the rebuilding of the riser wall. This included matching the brick bond and corbeling to the upper four courses. Ties and reinforcement meshing was installed to bond the new section of brickwork to the surrounding areas.

A second lintel was then installed to the upper section of brickwork to allow the coping stones to be installed earlier due to the time constraints within the possession. The coping stones were then re-laid and pointed up allowing for expansion joints as required.
